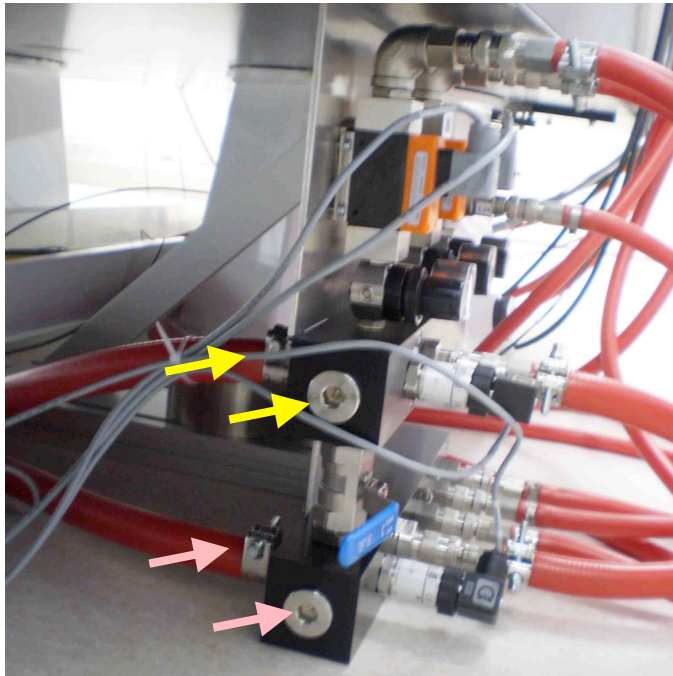
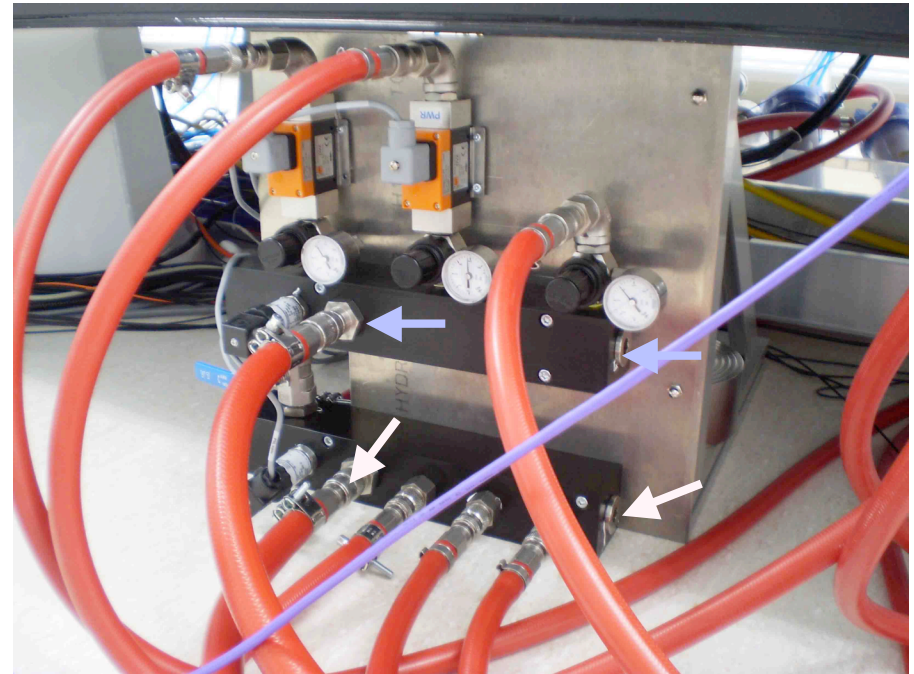
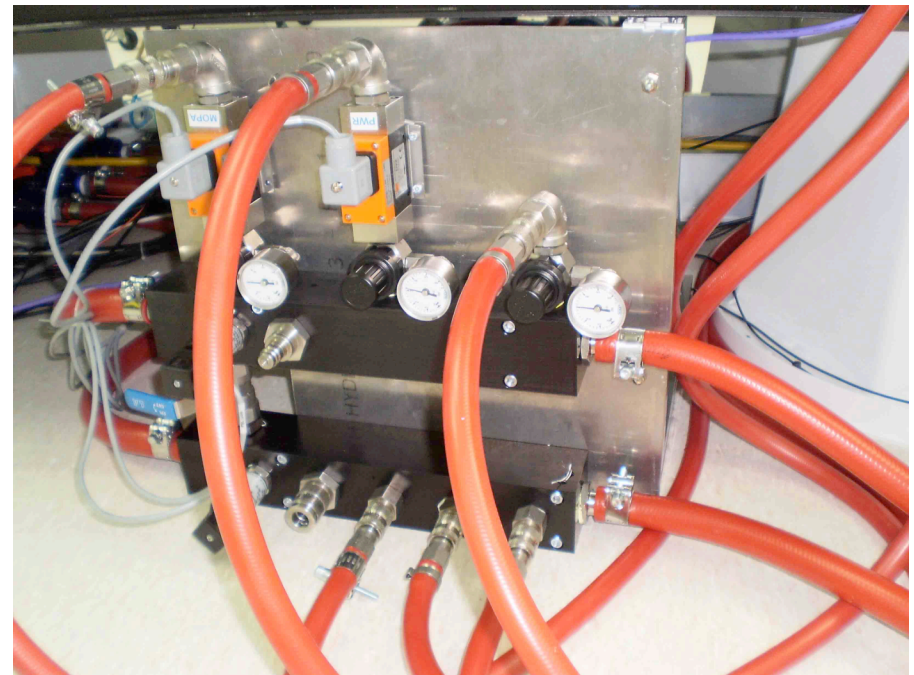
No further measureable improvements were made with these changes, but these changes may reduce laser jitter etc. Four hoses indicated by colored arrows were moved to burred connectors installed in the capped hole indicated by the same color arrow. The bottom picture shows the final configuration.
