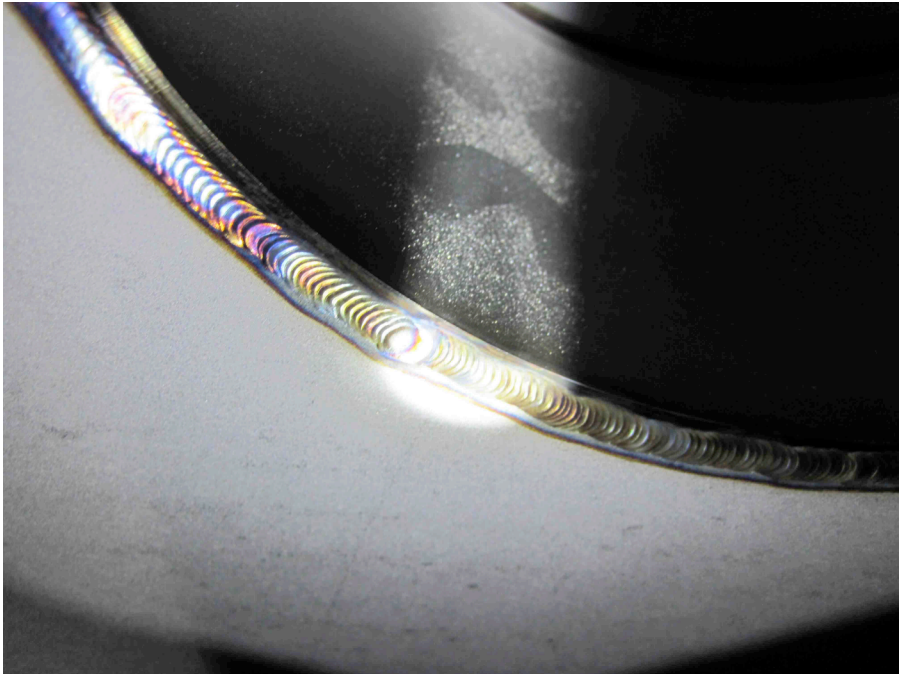
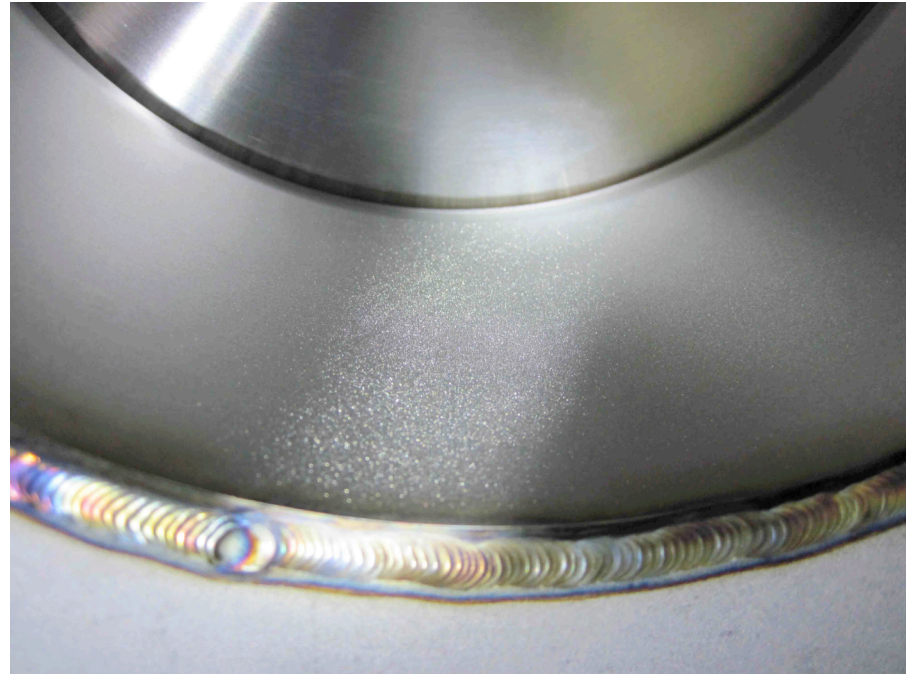
Top 2 photos are of nozzles in the 2K IMC tube. Bottom photo is of a nozzle in HAM3. There is much less particulate in the nozzle suggesting that vacuum cycling is not redistributing the particulate rapidly.
