RED: quick connects in high flow crystal box manifold, BLUE: 2 quick cons replaced, BLACK: chiller off

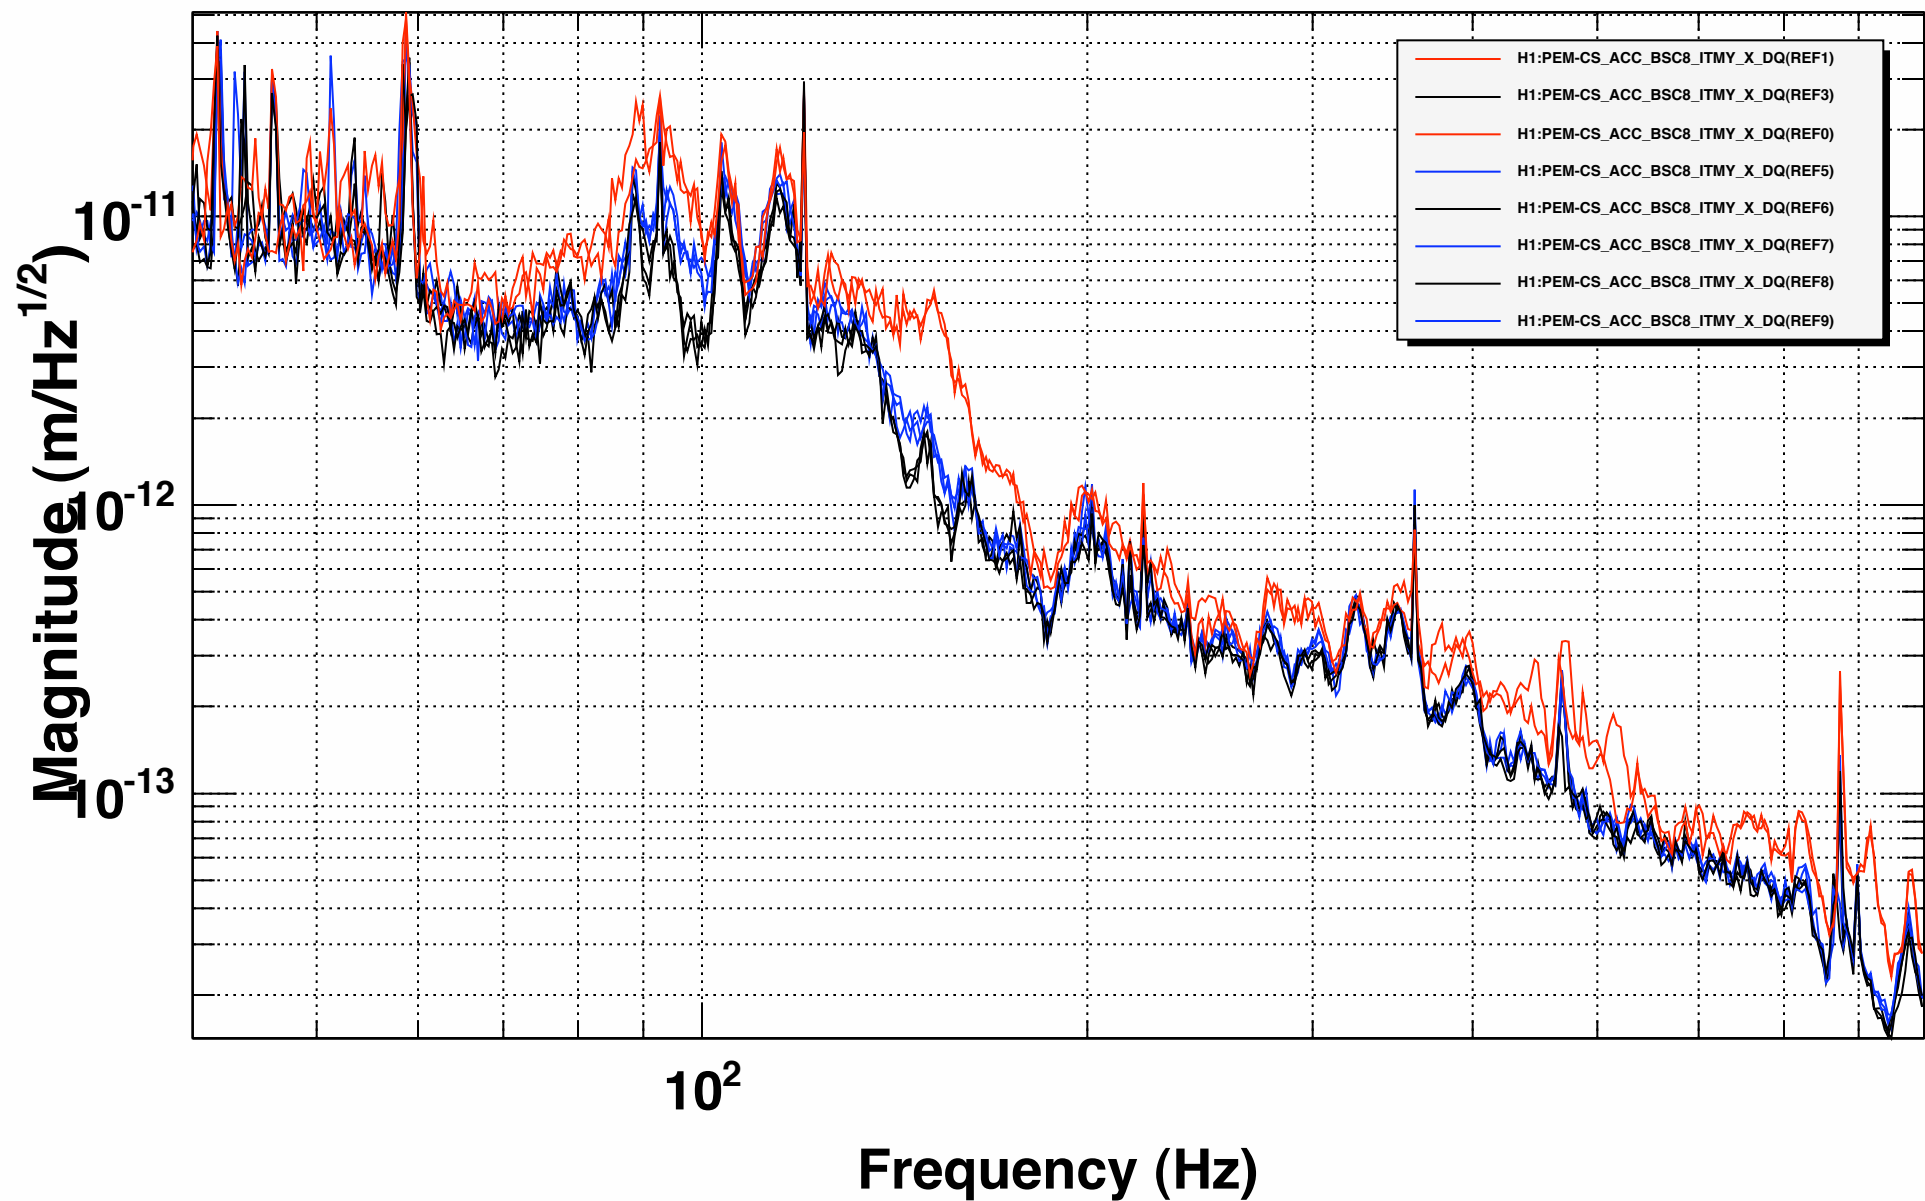
\*T0=12/12/2012 17:55:06

Avg=1/Bin=5L

BW=0.187499
